## Tech Note 113 Ford Ranger / Mazda BT-50 Clutch Damper

Ref: TN113 Issue Date: April 2020 Issue Number: 1

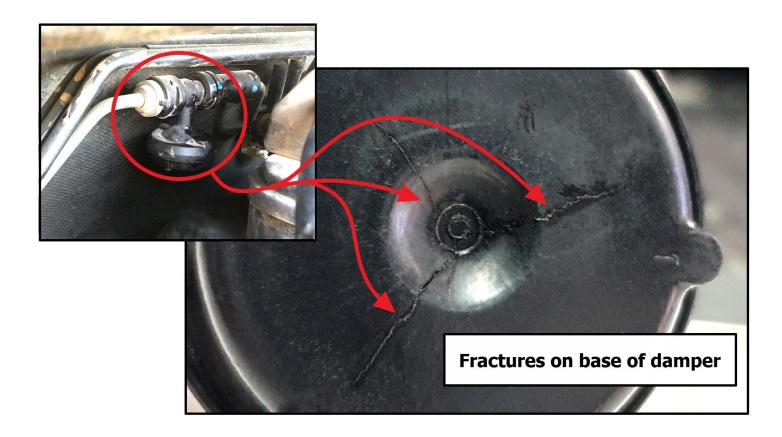
The hydraulic clutch damper located on the firewall (circled in the image below) can perish over time and close inspection of the damper is required at the time of clutch fitment.

Failure to identify or replace faulty clutch damper may result in loss of pedal pressure and/or difficult gear selection.
